WOODBURY COUNTY AGENDA ITEM(S) REQUEST FORM

FY27 Capital Improvement Requests 1. Auditor 2. Building Services 3. Bldg Svs/Juvenile Detention 4. Conservation 5. Siouxland District Health 6. Emergency Services 7. Secondary Roads 8. Sheriff 9. Treasurer 10. WCICC

Project Name: District 5 Hornick Secondary Road Maintenance Facility

Secondary Roads Capital Improvement Program

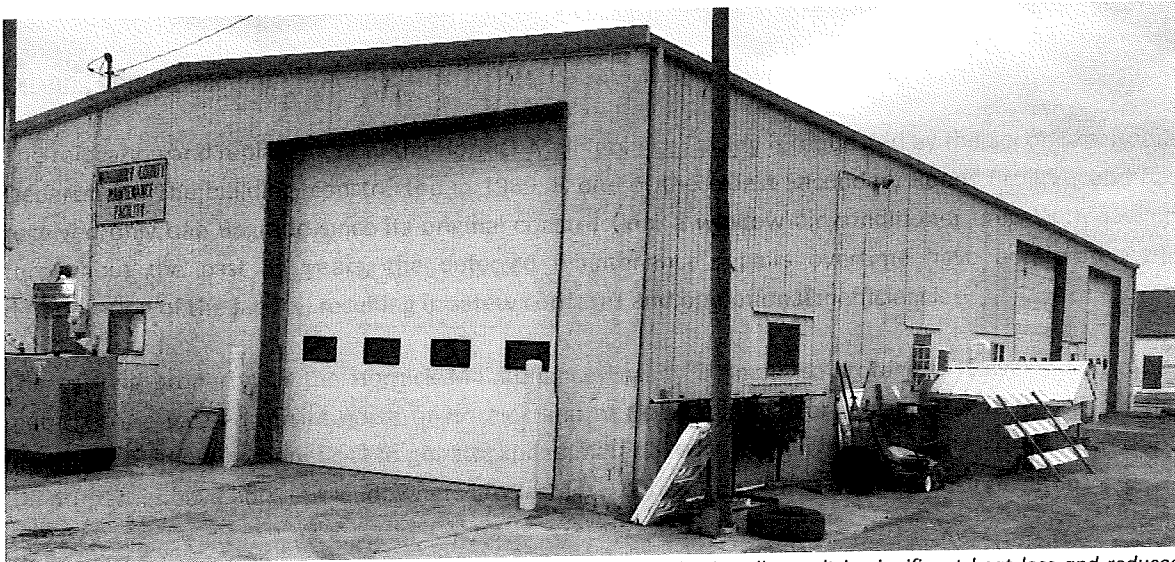
Hornick Maintenance Facility – Large gaps between overhead door and sidewalls result in significant heat loss and reduced efficiency during winter operations.

With limited overhead doors, equipment is usually scraping the door frames as the equipment squeezes into the facility. One plow needs to be removed daily in the winter months, so all the trucks fit inside overnight.

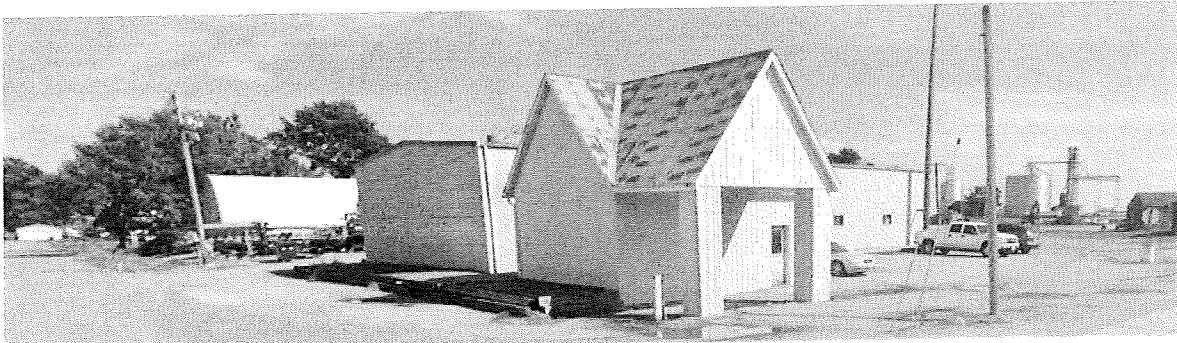
700-ft storage building is too small

The storage building is used to house the bulk purchased tires. With only a walk-in door, all materials stored in the building are moved by staff and not equipment. The cold storage building cannot house the sign trailer that is set up for emergency closures of roadways. This also means the signs sit outside 365 days of the year and quickly diminish their useful life from the sun. The pickups, semi, trailer, loader, and at times the skid steer are parked outside due to the existing facilities not being large enough to house all the equipment used in District 5.

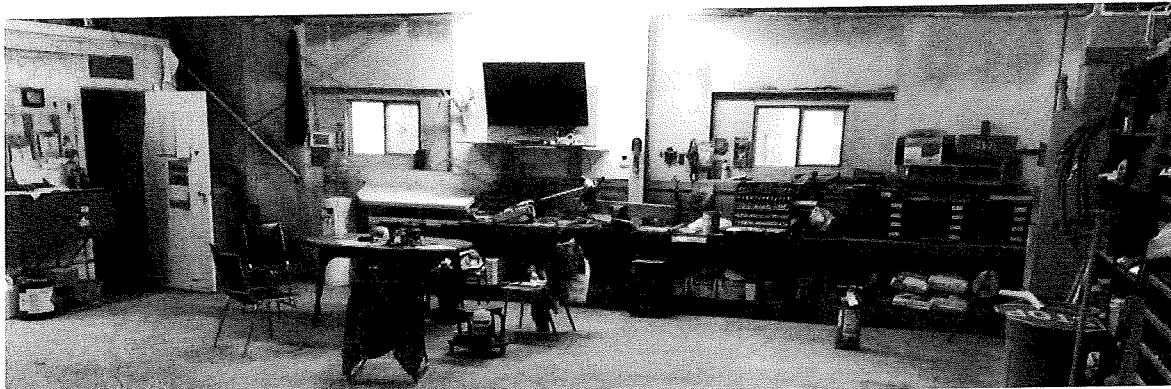
Makeshift Conference Room/Breakroom – employees sit next to snow equipment, does not allow for adequate safety meetings.

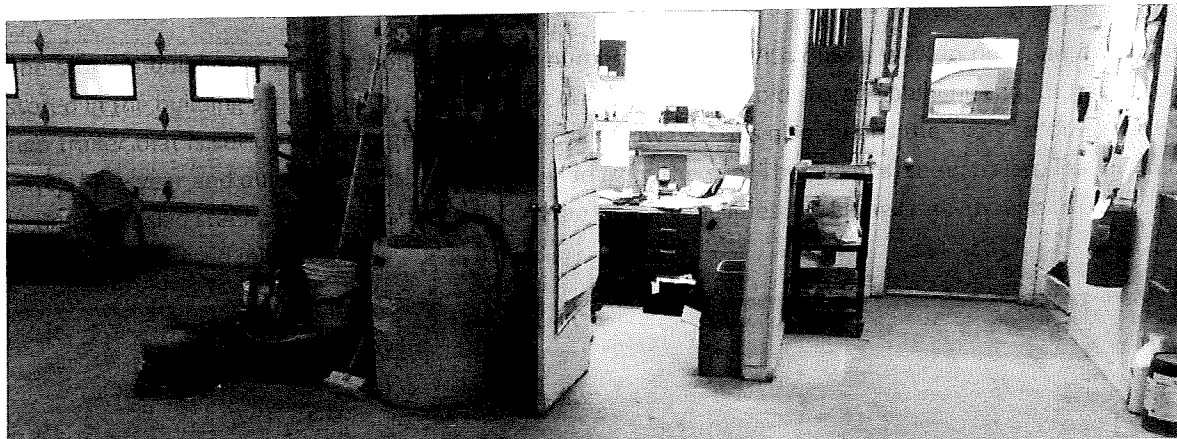
Closet space has been used as Office/Document Storage - limited office and document storage space.

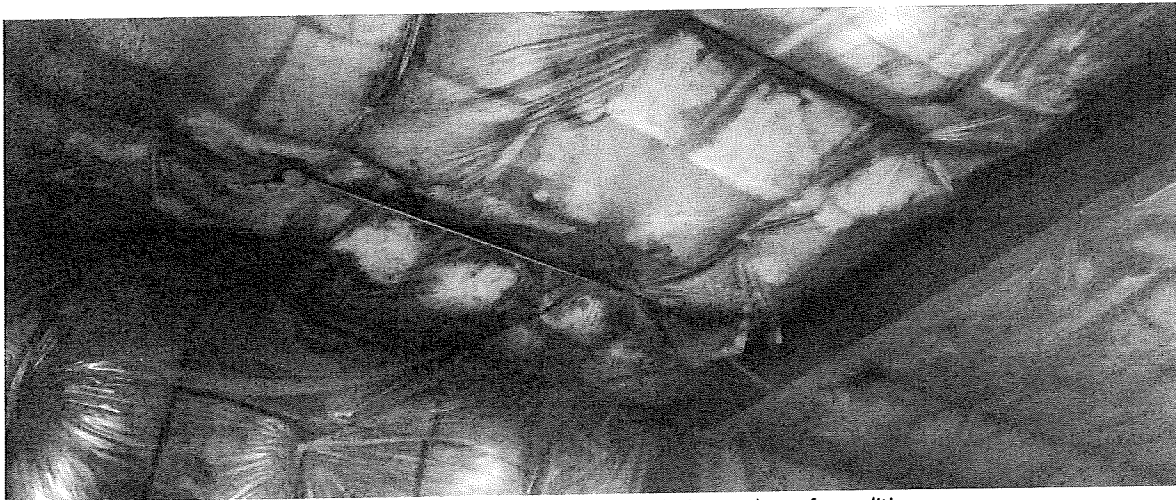
Ongoing roof leaks and deteriorated insulation contribute to structural decline and unsafe conditions.

These conditions directly impact employee safety, morale and equipment longevity.

I. **Structural Issues:** The roof leaks, sidewalls are rusted through, large gaps between the overhead doors and frames, and the floor around the drain is eroding. A new, well-maintained building would resolve all these problems.

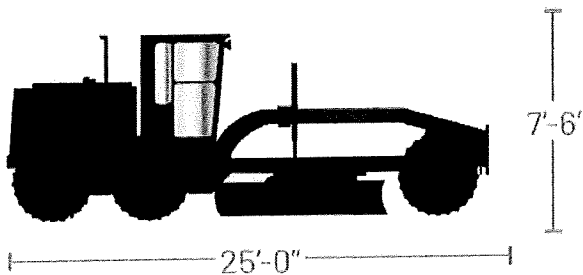
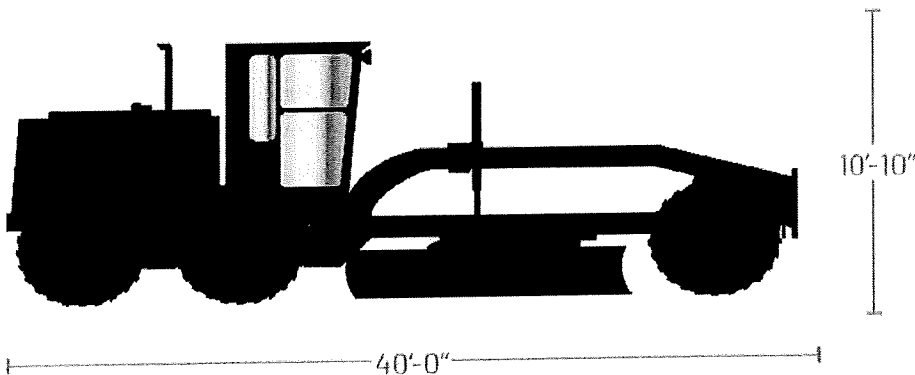
- D. **Storage:** Insufficient space for bulk oil and DEF systems. Inadequate door opening to use equipment to move heavy tires. No room for storage of emergency road closure signs. Either a separate storage building or a bit larger main facility would provide adequate storage for all equipment, tires, signs, etc.
- E. **Size:** The current building is too small, and not all equipment can be housed indoors. The size of road equipment has changed significantly since the building was originally constructed. Pictured below is a comparison of the 1960's motor grader to the size of ones the County is using today. The minimum truck with snowplow equipment bay and motor grader bay would be 60-ft x 22-ft.

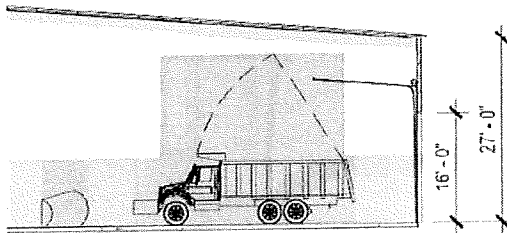
- F. **Heating:** Due to significant roof failures and damaged insulation throughout the building, the existing heating system is unable to maintain adequate temperatures during winter weather to fully melt and dry the snow and ice off the equipment before the next day of work.
- G. **Vehicle Washing:** There is no wash bay, forcing vehicles to be washed outside in poor weather or not at all because of freezing temperatures, accelerating equipment wear. The minimum specialty bays for washing and maintenance would be 80-ft x 34-ft with a 27-ft height clearance.

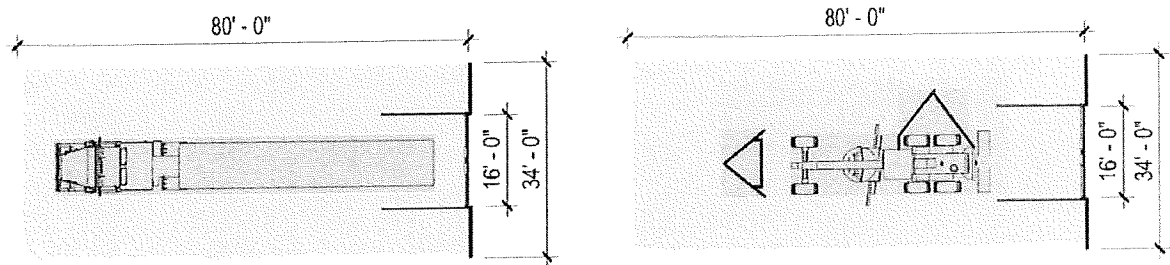
H. **Maintenance:** With no mechanic's bay, equipment being repaired requires even more equipment stored outside when there are delays in repairs while waiting for parts and available workspace. The ceiling is too low to lift equipment needing repaired, which limits the ability to repair equipment and to see all the issues with the equipment. Adequate space around equipment for repair work and cleaning of equipment is shown below:

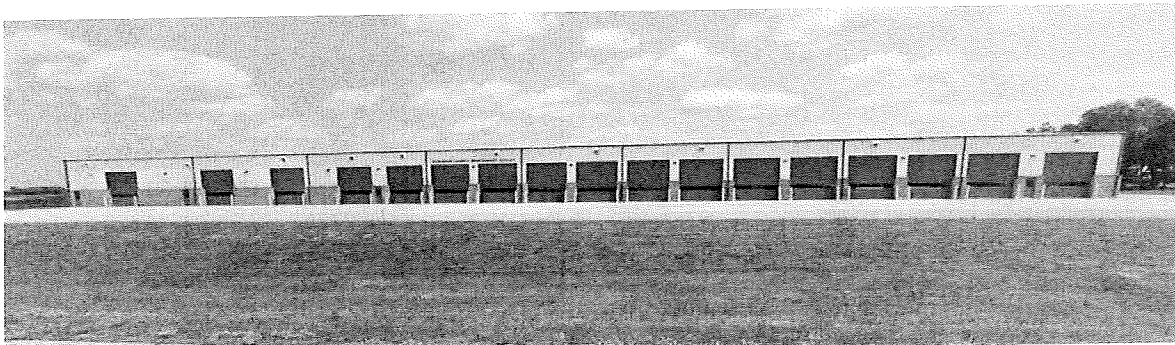
Dickinson County 2021

Other counties, including Dickinson County, have recently invested in modern Secondary Roads facilities, including a maintenance facility in Spirit Lake constructed in 2021. While costs vary based on size and features, these projects demonstrate the ongoing need for counties to replace aging infrastructure. Based on current construction costs and the operational needs of Woodbury County, a building cost in the range of \$4,000,000 is a reasonable and supportable estimate.
