Dorothy Pecaut Nature Center

CIP Request

Observation Deck

Dorothy Pecaut Nature Center
CIP Request
Retaining Wall, Garden Area

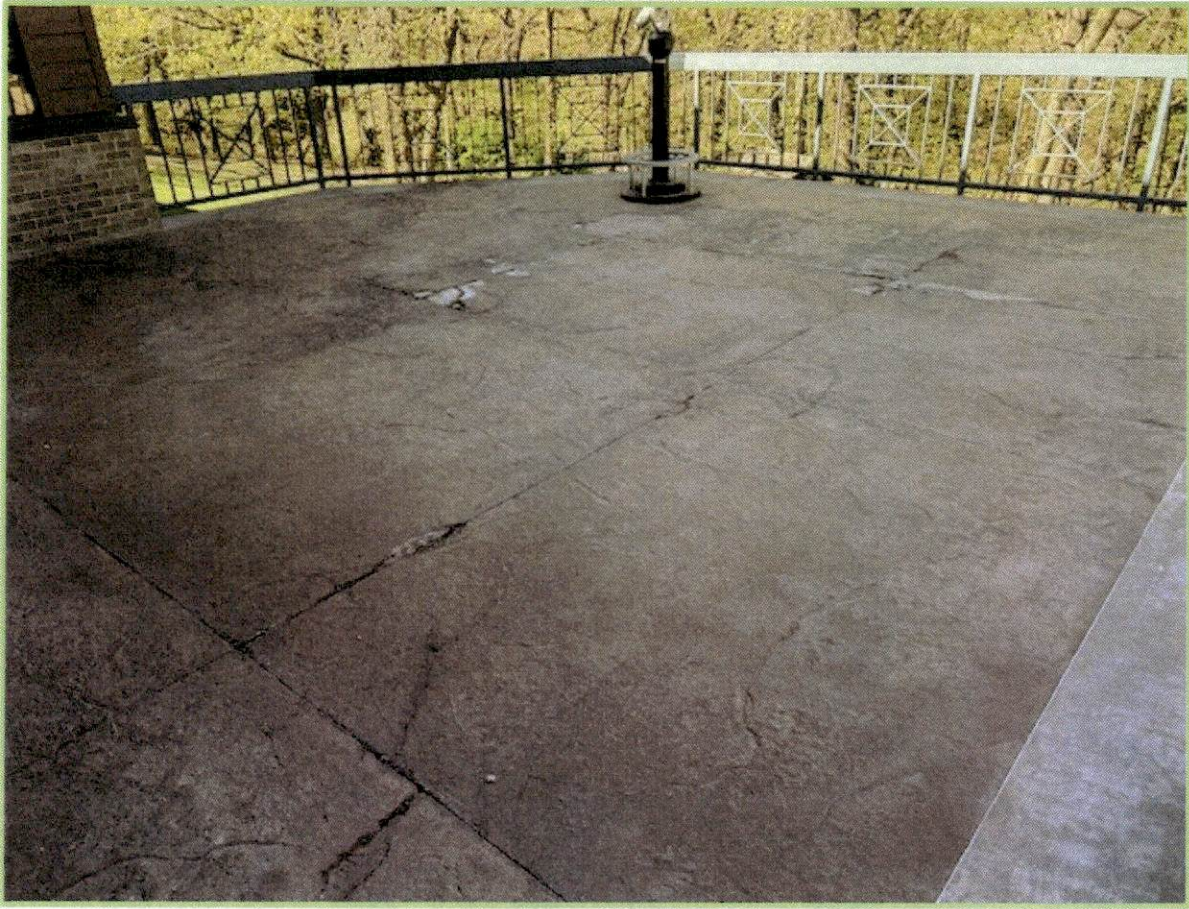
This CIP request is for the Observation deck concrete that is failing. This was a decorative concrete coating put on years ago that is heaving and breaking out due to freezing and frost action. Moisture gets in and under cracks and pops the coating up. We have had contractors come and cut out sections and repair, (See Photos) and as you can see the problem continues. This creates a tripping and slipping hazard as this stuff breaks up and comes out. This is a liability for the county and does not look good to the general public.

Observation deck as you enter the entrance to the Nature Center. Cement coating is sprawling and cracking and breaking out. We have tried to have it repaired and it continues and is getting worse. Becomes an eyesore as well as a tripping or slipping hazard.

The fix is to cut along the border leaving the outside concrete, bust out all the old in the middle and re-pour just concrete to match the border. While we do that, we want to remove the bridge approach to the Nature Center as it is failing underneath, replace it with a culvert and bring in soil and put a regular sidewalk up to Nature Center. This bridge is icy in the winter and hard to keep snow and ice off, thus another liability. We will then landscape so that we can install a handicap sidewalk to the lower sidewalk. This will allow people to access the playscape and the lower sidewalk. This is all included in the request and we do have a quote from contractor solidifying those numbers.

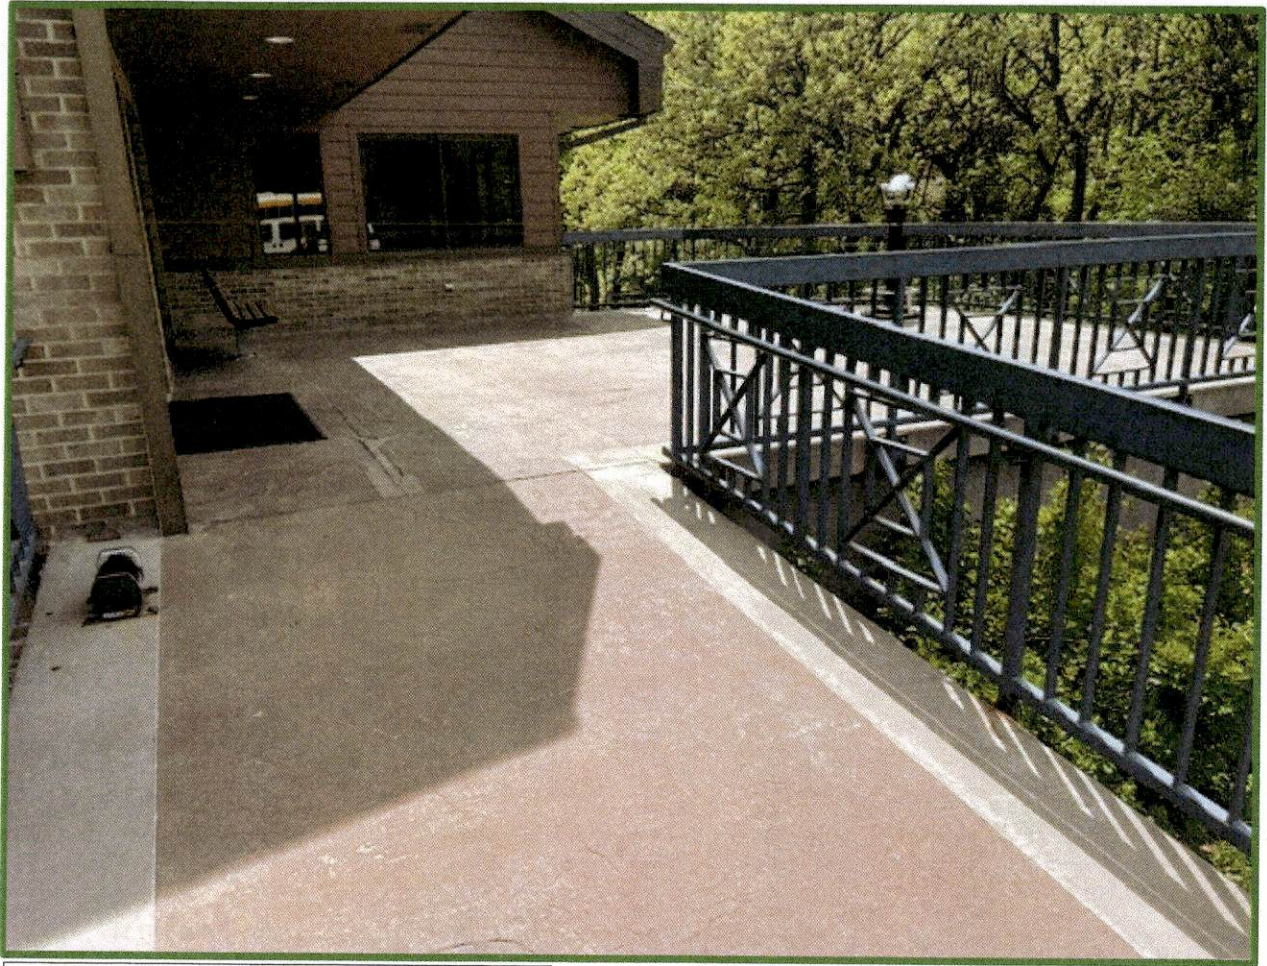
Above is the top of the ramp and entrance to Nature Center and deck.

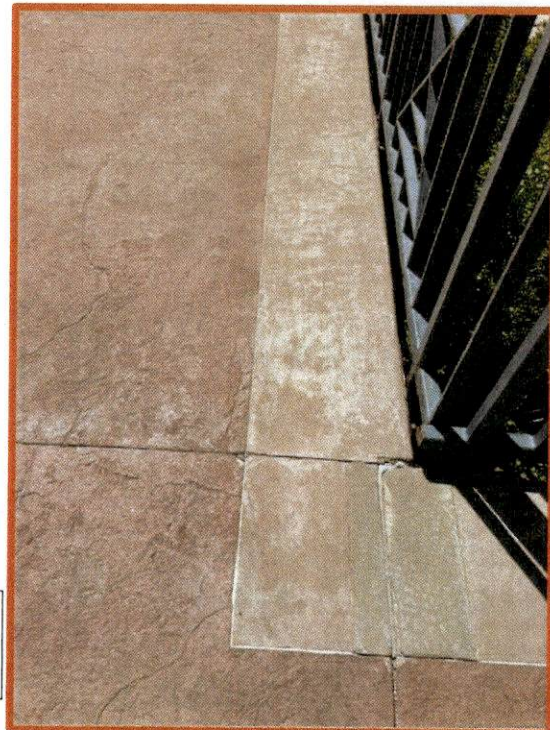
Edge where we would saw along so we could bust out red colored concrete.

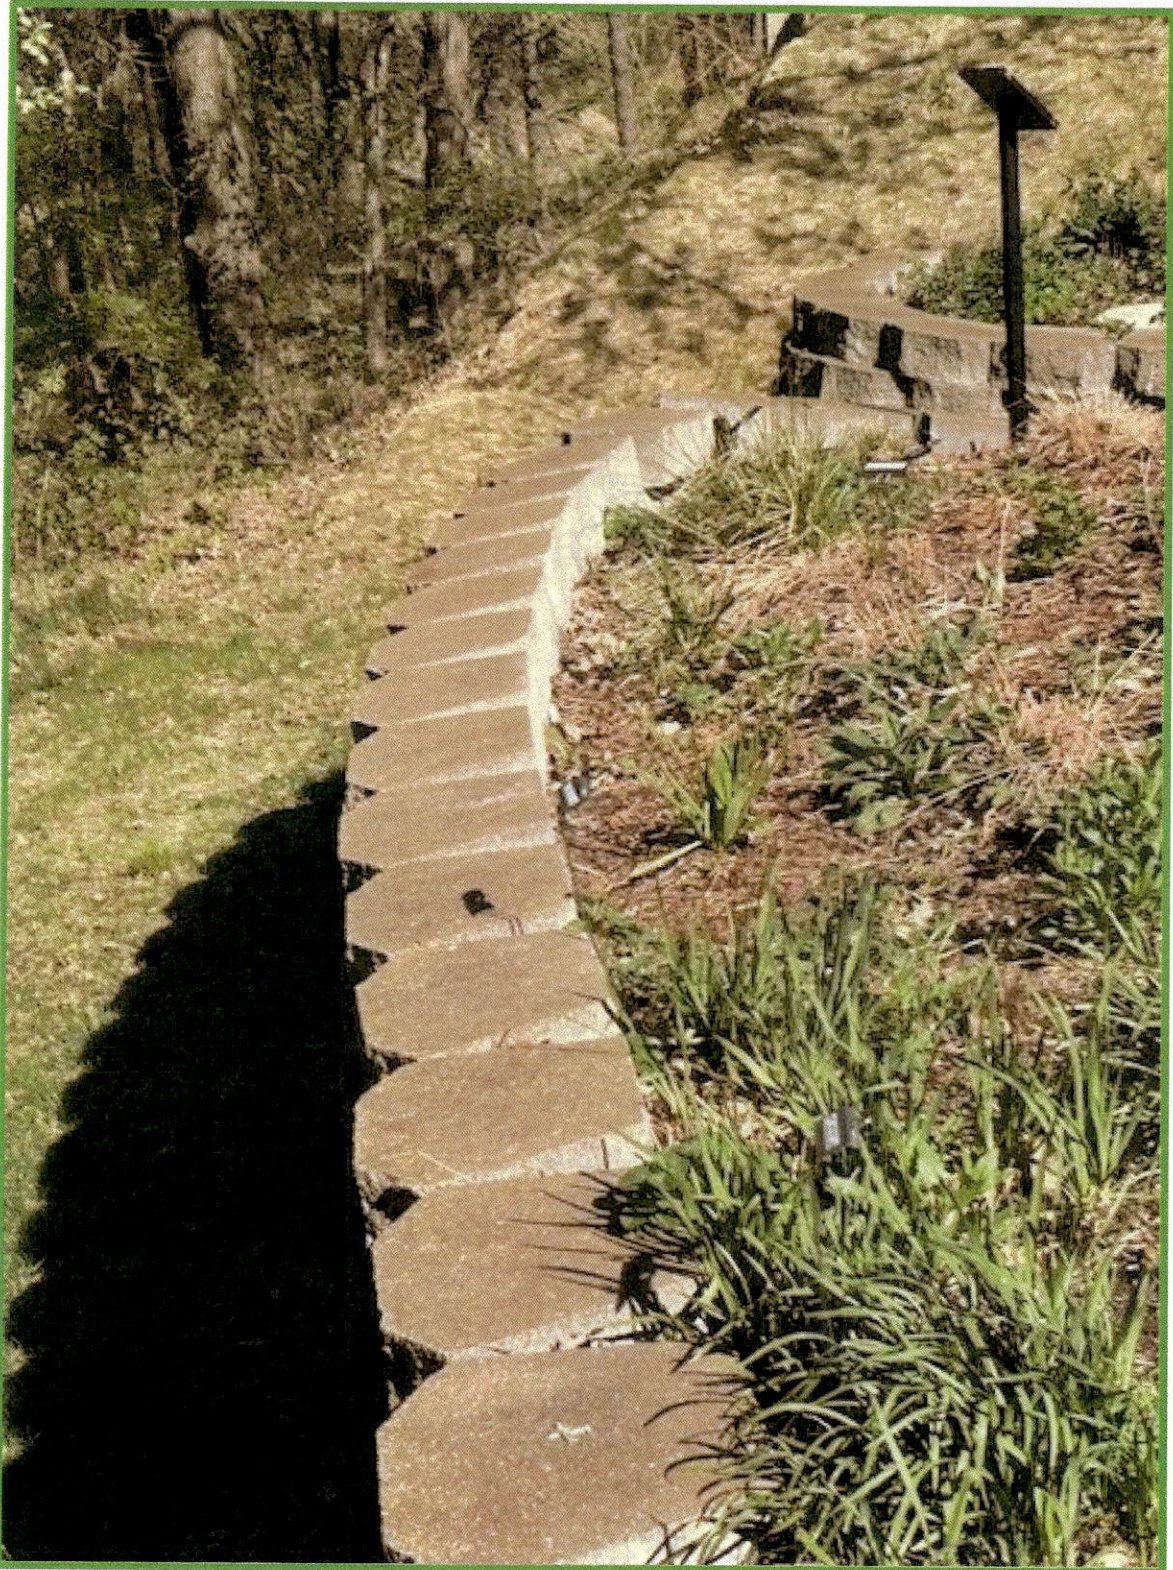
This CIP request is for the retaining walls and steps at the gardens up front by the Nature Center as you enter. This is a 3-tier garden with steps going down the middle with gardens on both sides featuring native grasses and forbs. These walls are failing by starting to fall over by leaning, (see Photos). This is happening along the whole length and on the corners of stairs. Kids and adults alike walk up and down these stairs and, on the walls, and I am afraid sometime the wall will collapse, and someone will be hurt, thus a liability for us.

Garden retaining walls are shifting and leaning becoming a liability as well as an eyesore.

Plans are to make a poured wall like the one we did for the shelter area. (See Photos) We would tie into this wall and stair step it down as we go tying into the landscape as we go. They would pour tie in walls that go back into the side hill so that walls will not move or lean. Prior to this project starting, staff and the garden club would remove plants to a temporary garden while construction takes place. Landscaping stones would be removed by staff and repurposed in the parks. The contractor that poured our original wall for the shelter gave us the quote for this project as well. Plants would then be moved back from their temporary gardens and into the new area.

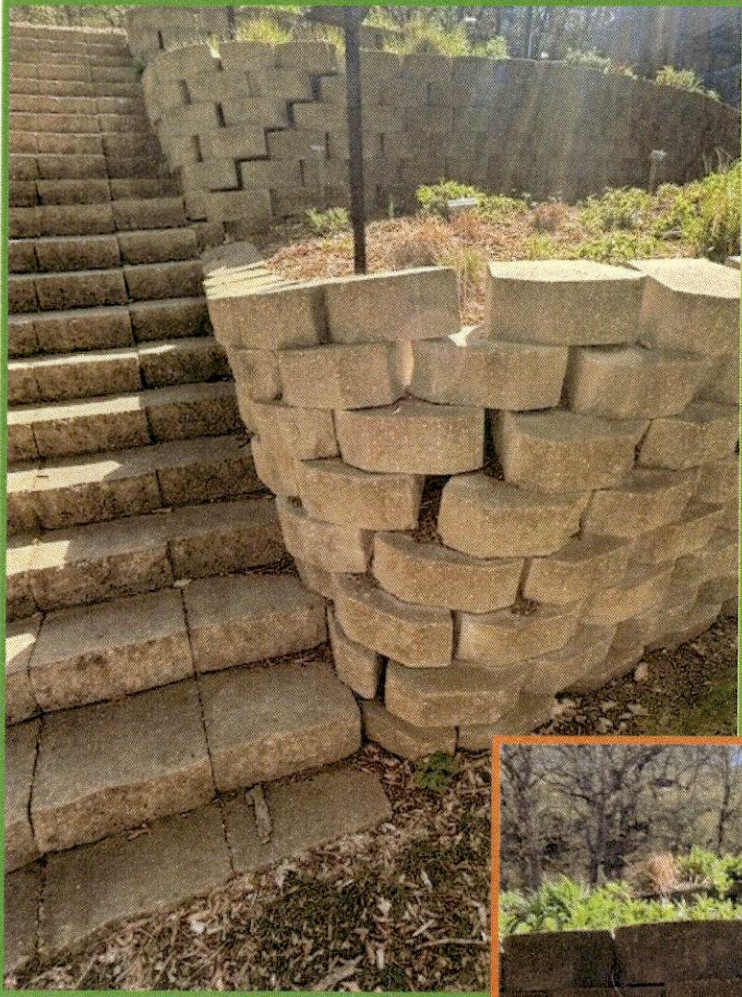
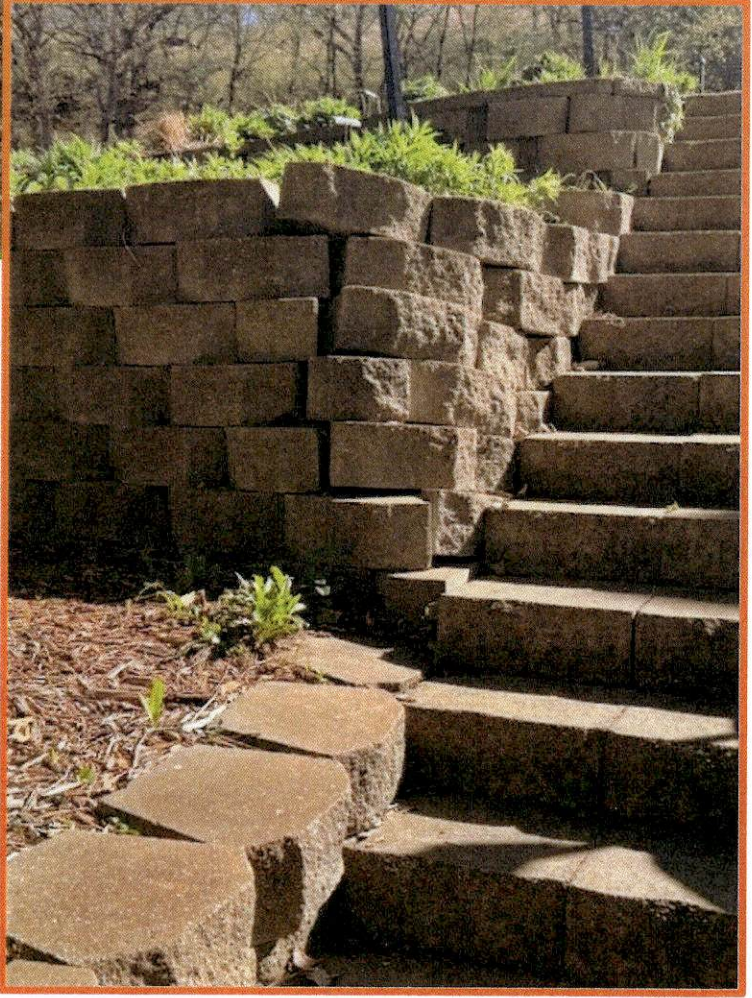
Corners of retaining walls blowing out on both sides of steps. Liability, especially if kids are climbing on which they do.

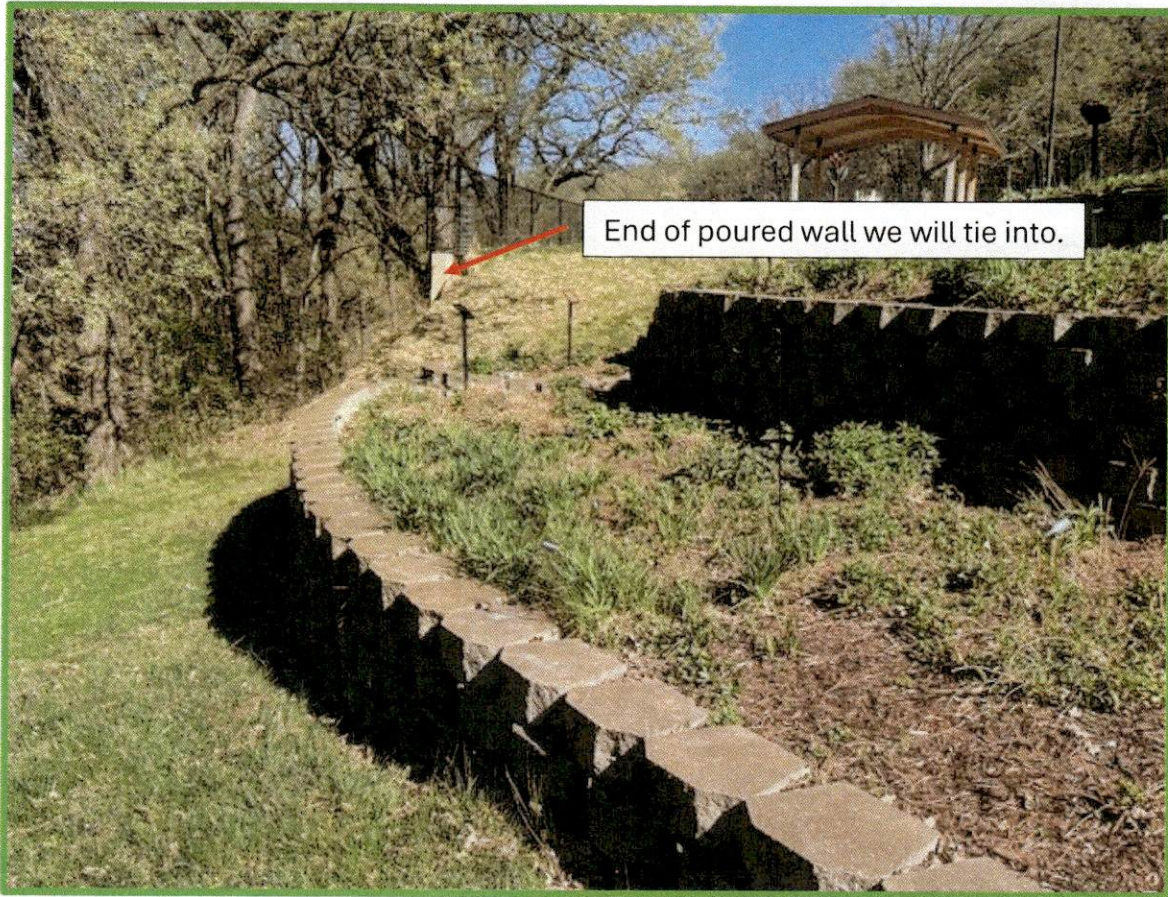
Plans are to tie into the existing poured wall with boulder face and stair step it down as we wrap around into hillside. Wall will be tied back into hillside so it doesn't move as the original wall was when poured.

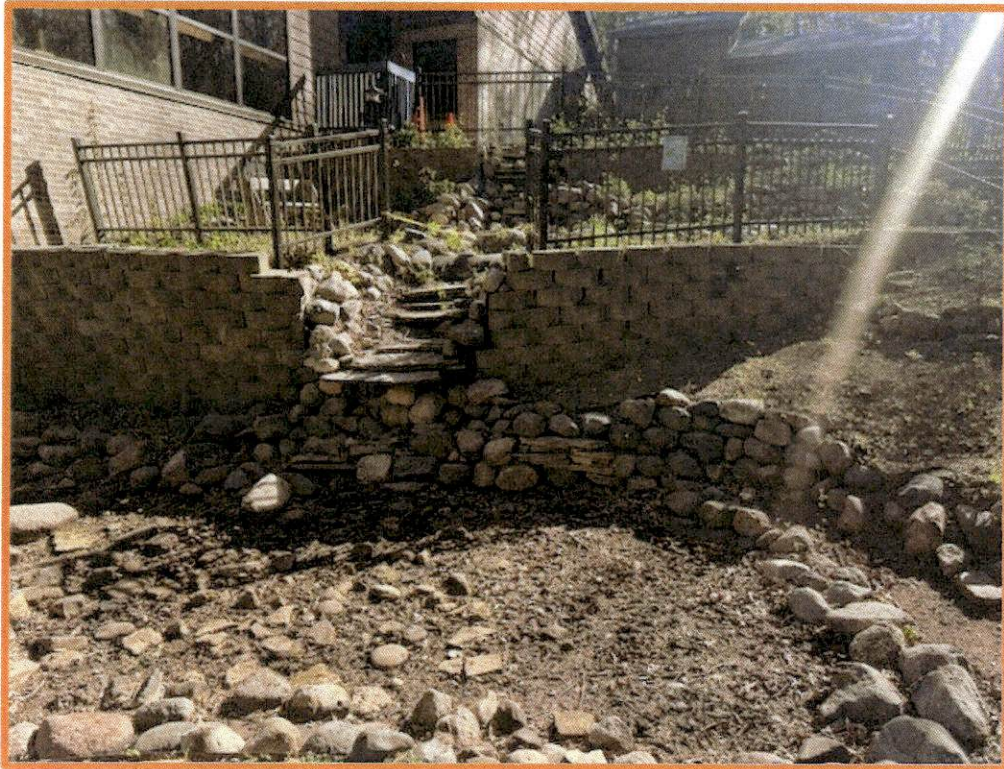
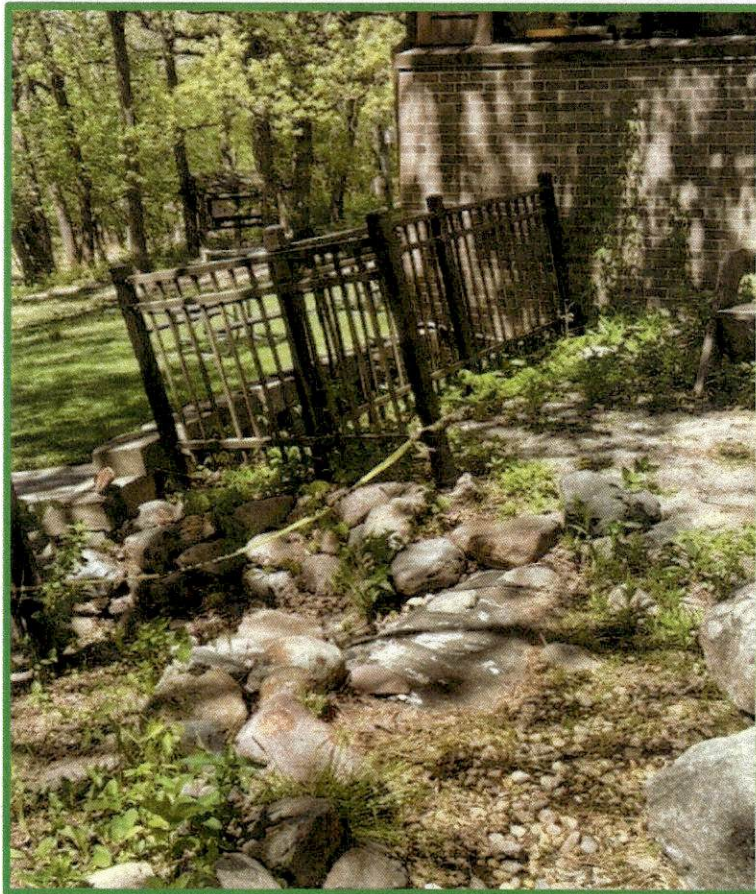
Bottom railing of water feature leaning due to soil shifting, this is not safe and is a liability.

The contractor has quoted that the only way to fix this is this to remove the walls and soils and start building it back up using geo grid in the process. They would use geo grid all the way up and build two walls and make two levels that will be useable by the public. Bench area and maybe a picnic table area. The water feature would be moved over and down to the lower level along the sidewalk and not be incorporated into the walls as it is now, thus removing any potential problems in the future. Moving water attracts birds to the feeders and amazingly cricket frogs that seem to sing a chorus all day long and are enjoyed by our Nature Center users.

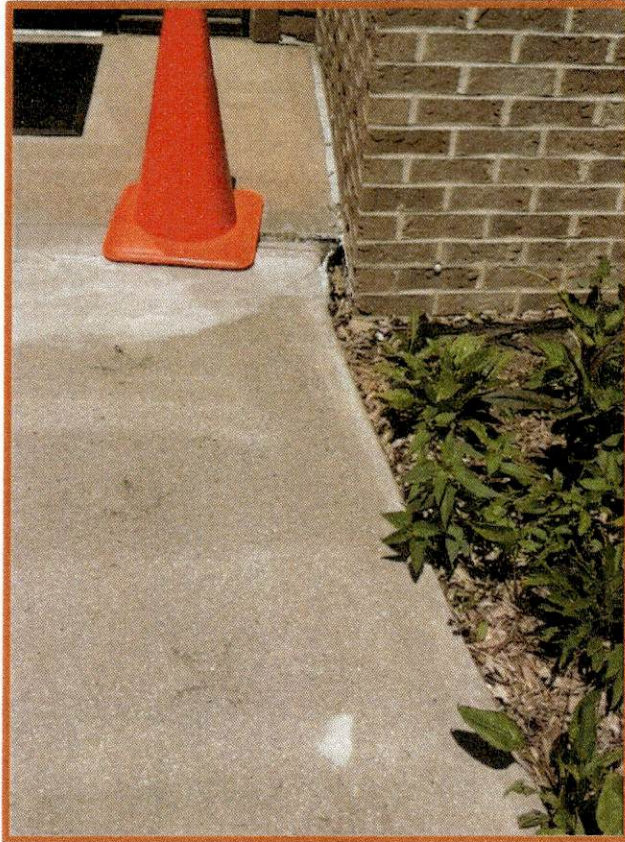
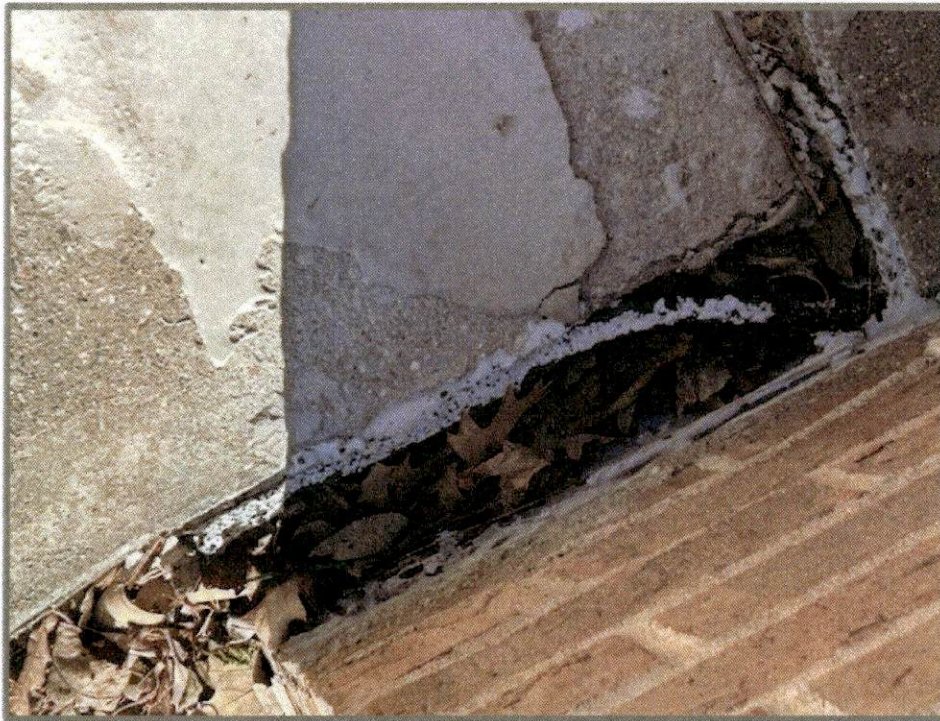
Sidewalk shifting away from building with side hill. Stoop behind it is pinned to building and has footing so reason it is not shifting with sidewalk. This is about a 3 inch separation right now and gets worse each year.

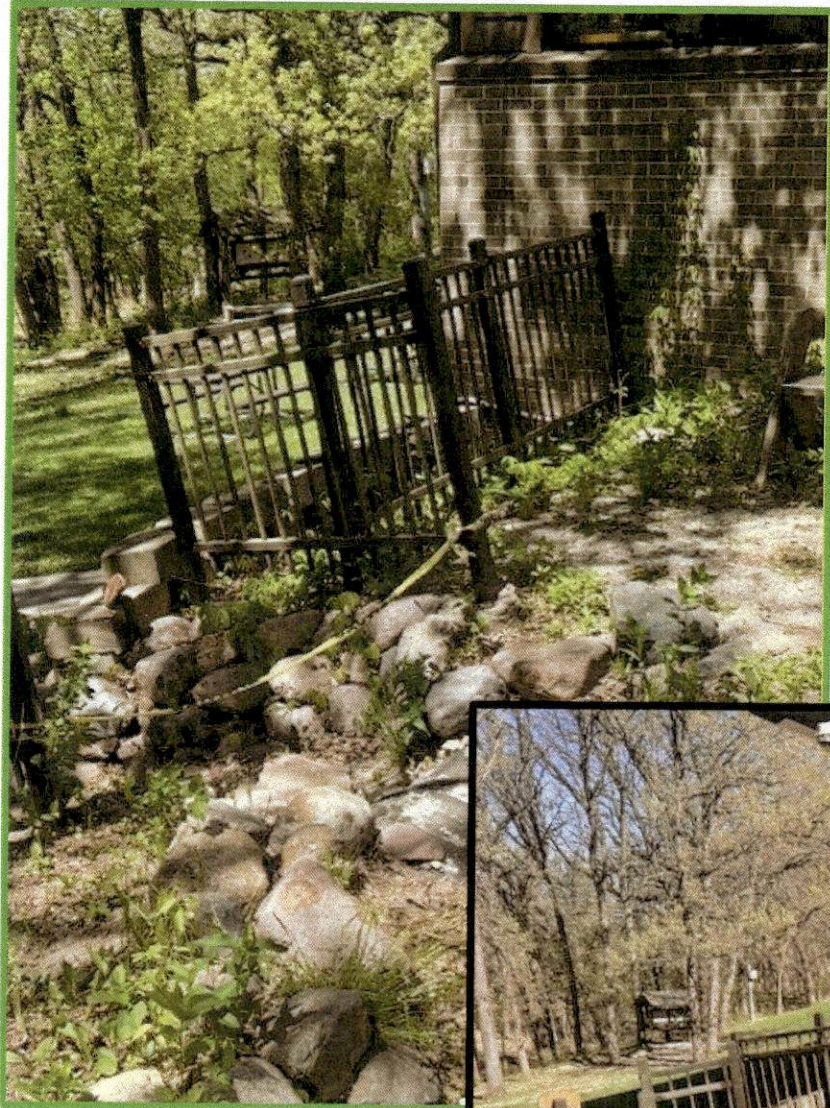
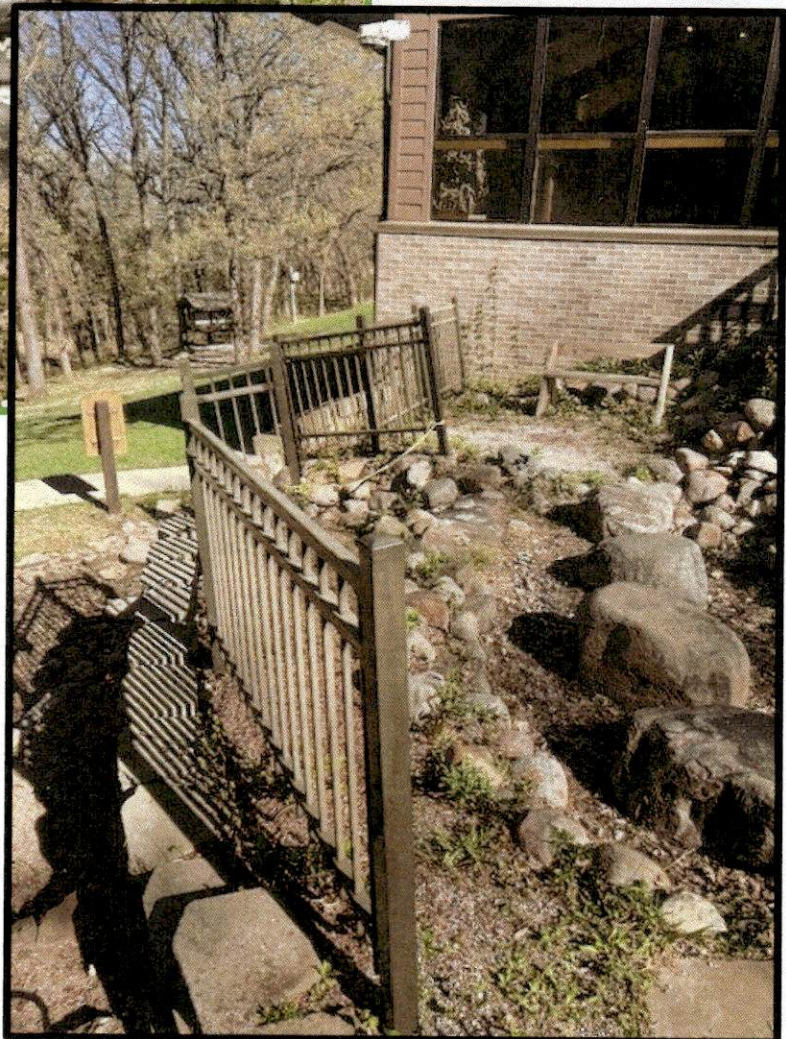
Lower level railing on water feature that are leaning due to shifting soils, this is a liability for us and is an eyesore.

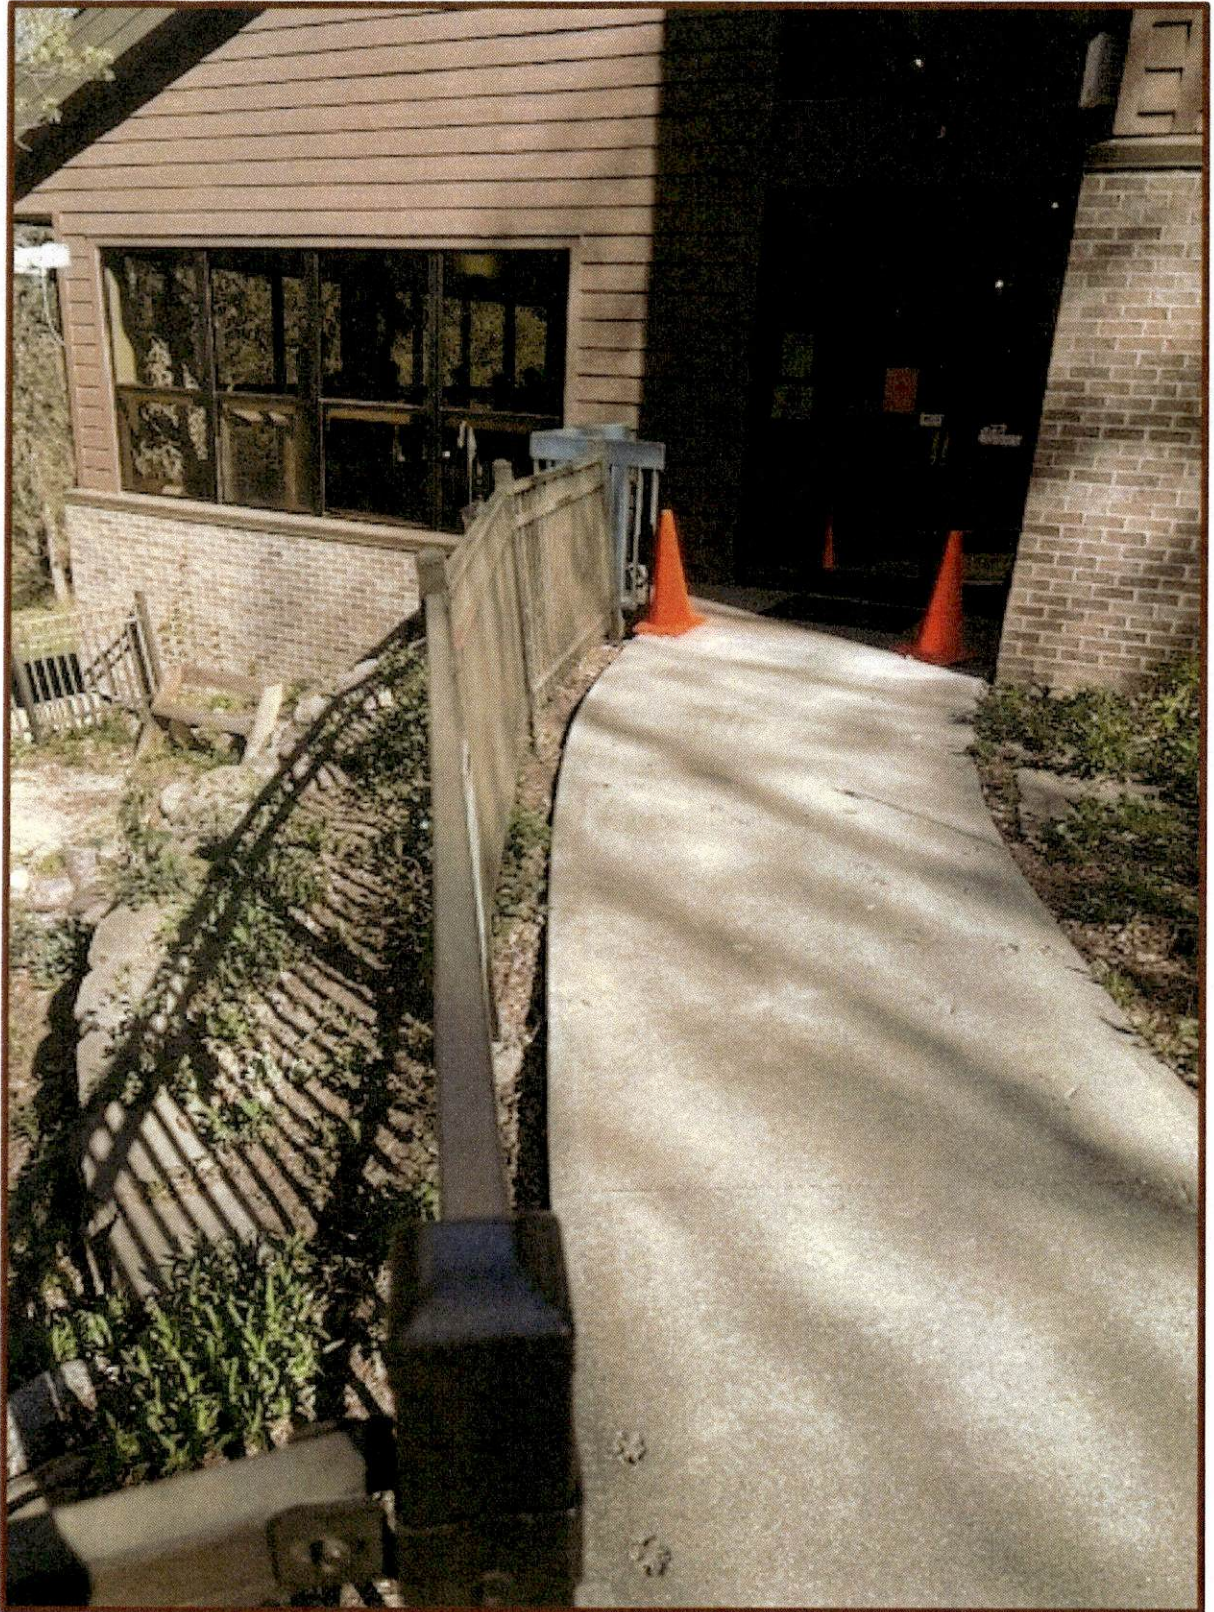
Upper rail of water feature near rear exit of Nature Center leaning due to shifting soils. This is a liability and is getting worse. Area between orange cones is sidewalk that keeps shifting and raising and we break out and fill as it becomes a tripping hazard.

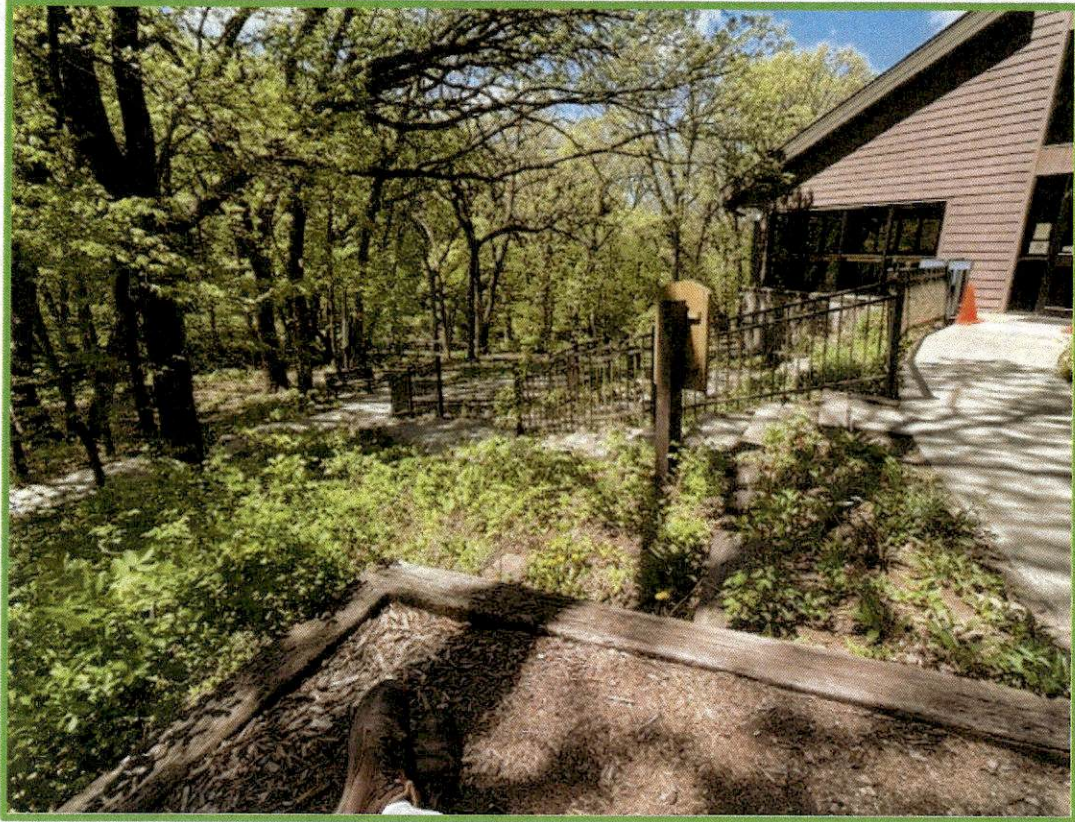
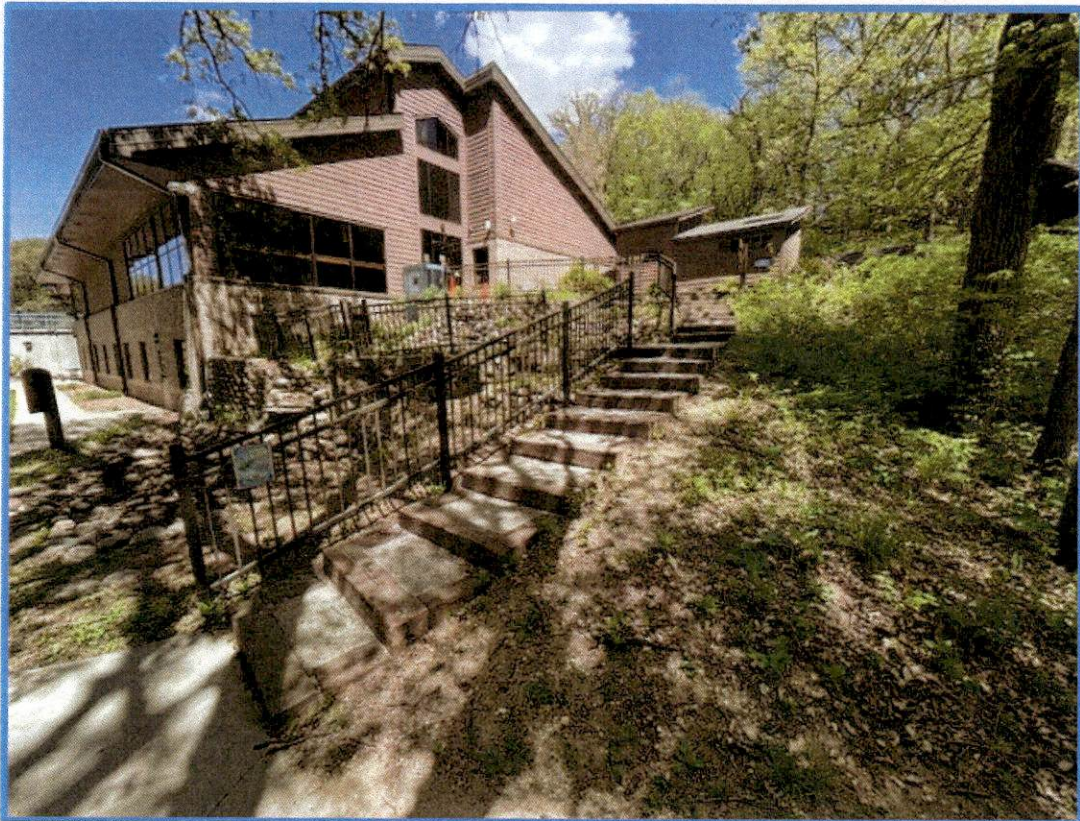
Overall view of the water feature area from above and below.
